RUNWAY FRICTION MEASUREMENTS AND PAVEMENT CONDITION
SURVEY, NPTREL CENTRO, CALIFORNIA, by

R. B. BROWNIE,

SEPTEMBER 1976,"

CIVIL ENGINEERING LABORATORY

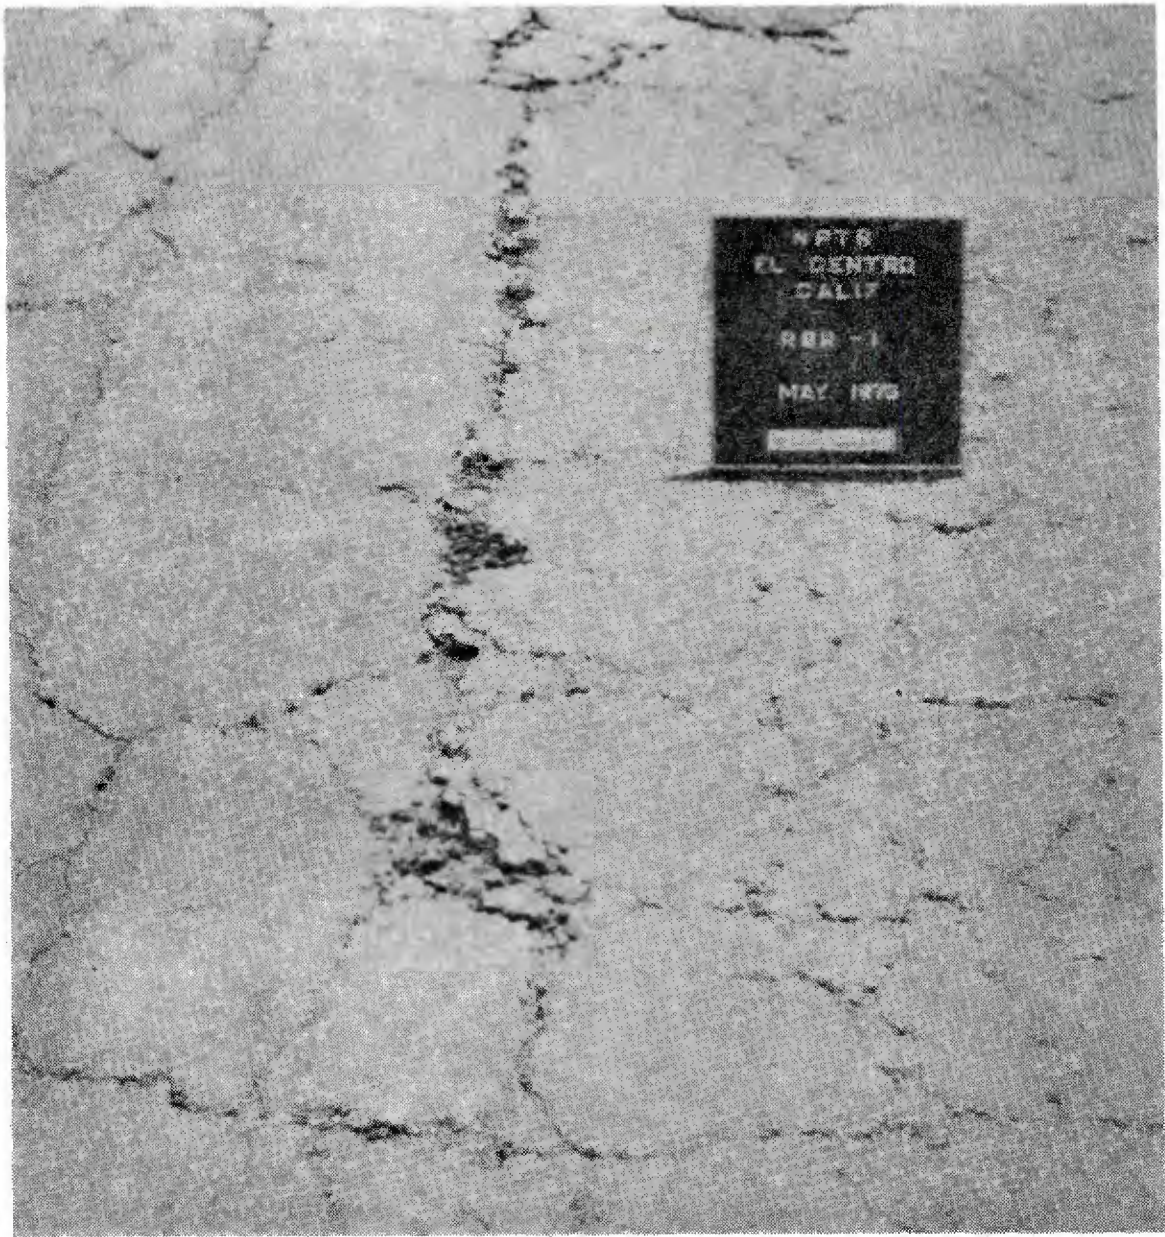
R8R-1: The substantial increase in pattern cracking is attributed to continued aging of the pavement surface. Many of the cracks tallied as longitudinal cracks in 1969 are now included in pattern cracking.

Figure 2. Severe pattern cracking and raveling,
Discrete Area R8R-1.

This seldom-used runway shows the effects of aging and little maintenance. The pattern cracking is mainly caused by shrinkage and hardening of the asphalt binder. Raveling is occurring along the cracks. See Figure 2.

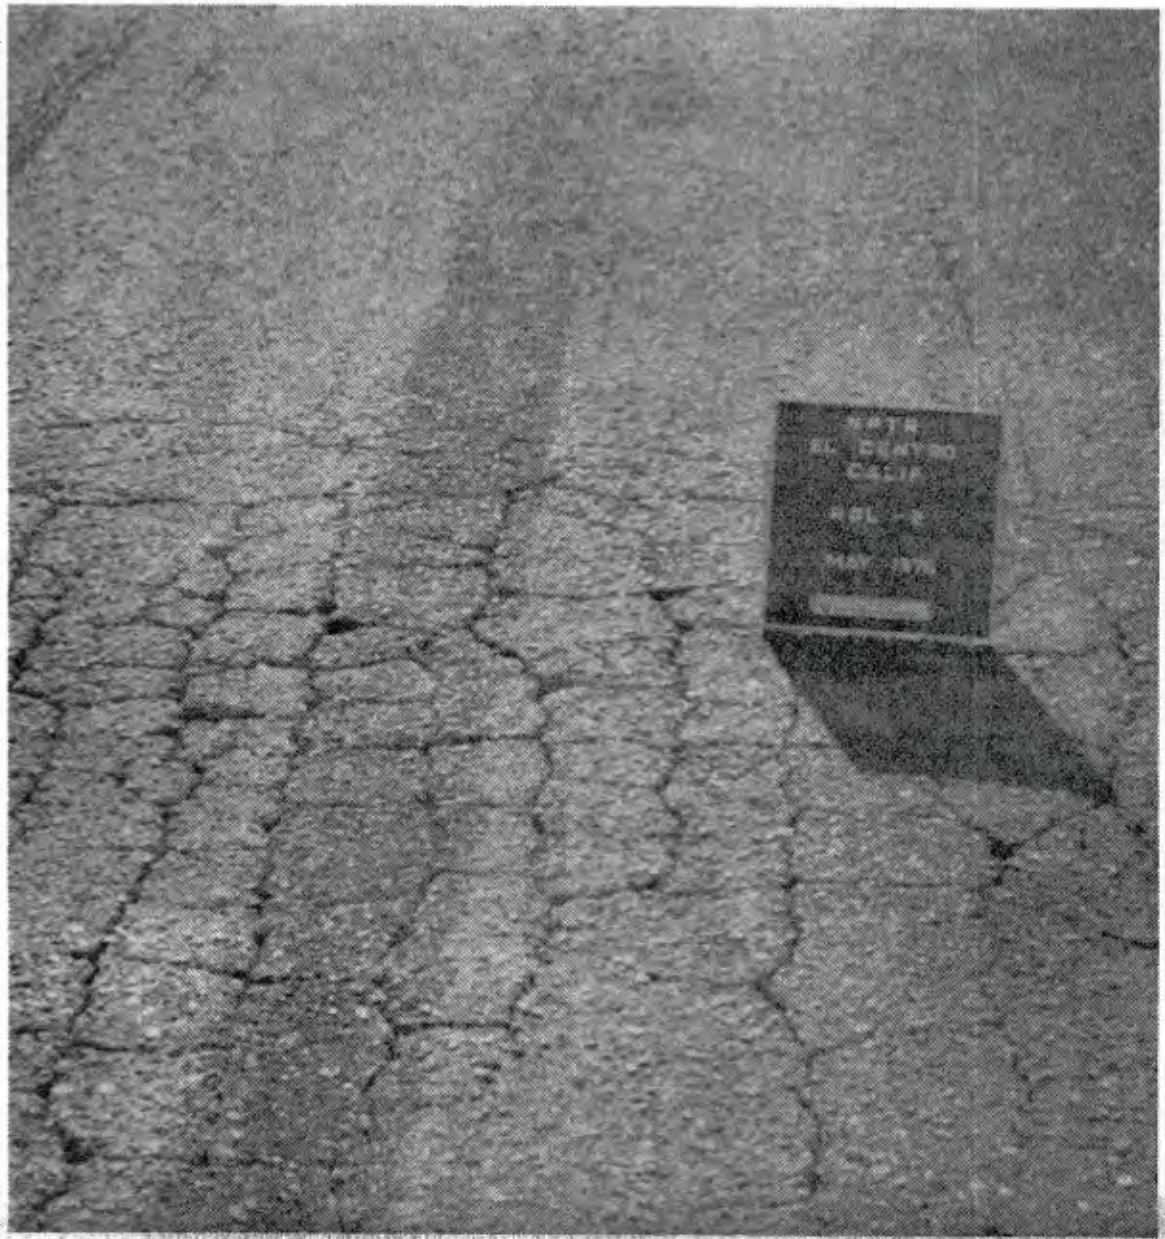
R8L-2: This area was overlaid with 2 inches of asphaltic concrete in 1970, shortly after the 1969 condition survey. Substantially the same amount of cracking was tallied in 1976 as in 1969 in spite of this overlay. In addition, the overlay had a large amount of raveling tallied in 1976. The raveling is probably caused by insufficient asphalt or poor compaction of the overlay.

Figure 3. Pattern cracking and raveling,
Discrete Area R8L-2.

The overlay placed in 1970 was raveling and had lost most of the surface fines. Pattern cracking has progressed to small polygons with some pieces coming loose from the surface. See Figure 3.

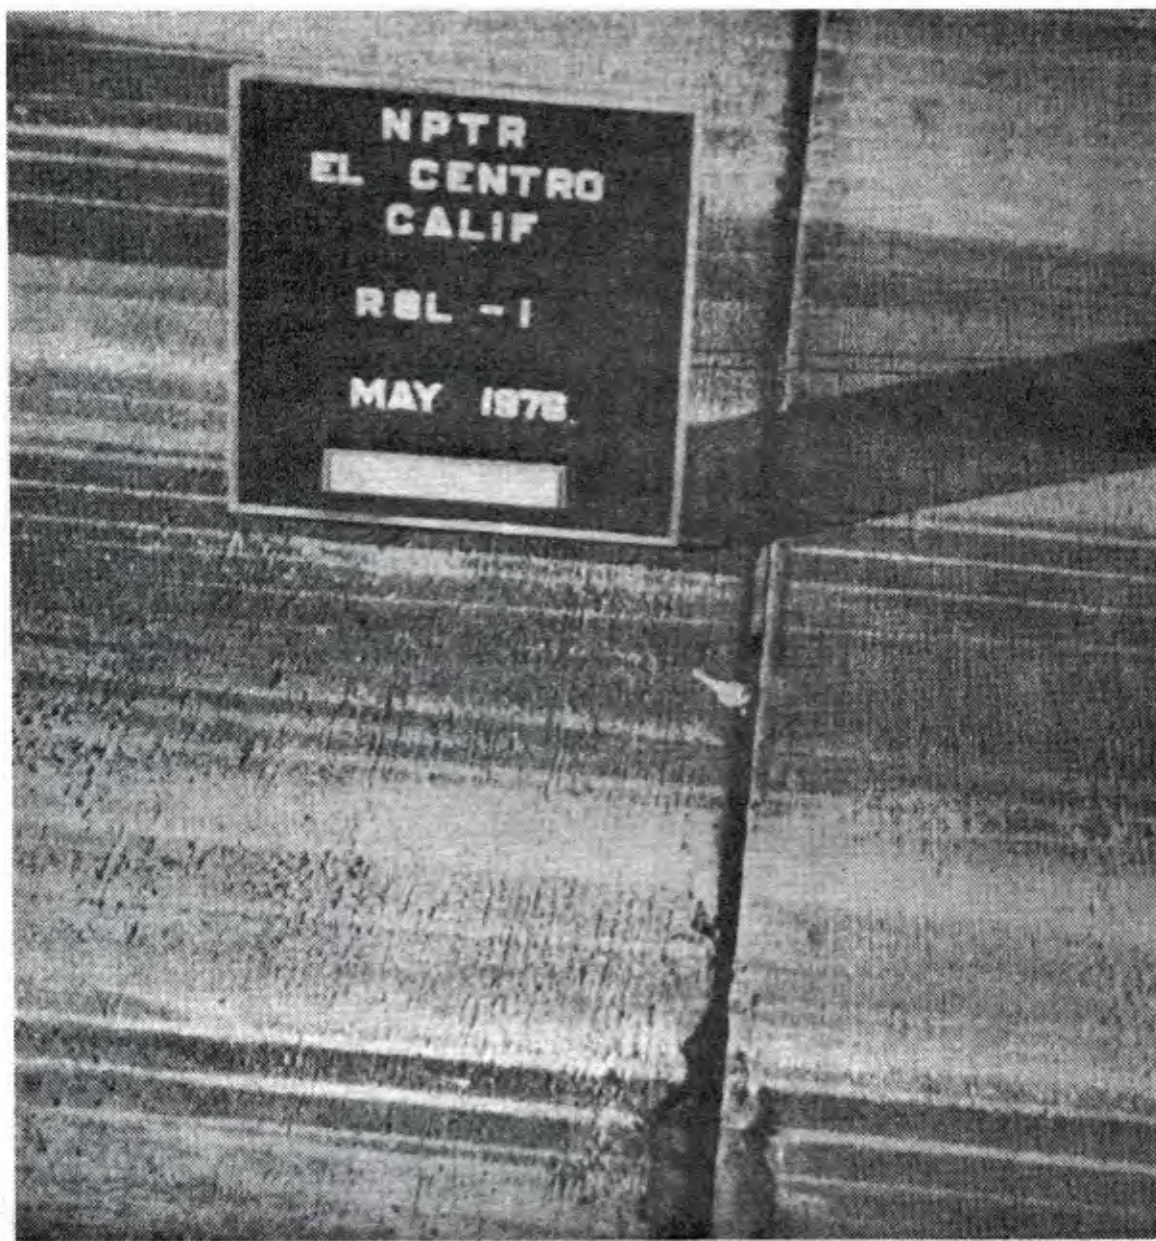
R8L-1: The largest change in defect quantities since 1969 was defective joint seal. This is typical of deterioration and oxidation of joint seal which is 17 years old.

Figure 4. Missing joint seal, Discrete Area R8L-1.

Defect Type	No. of Sample Slabs w/Defect	Total Slabs w/Defect: c x a/b	Defect Density (per slab) d/a	Defect Severity Weight	Weighted Defect Density e x f
	(c)	(d)	(e)	(f)	(g)
Faulting					
Corner Break	3	12	0.022	3.5	0.077
L.C. or T.C.*	2	8	0.015	3.5	0.052
I.C.**					
Depression					
Spalling	19	76	0.142	7.5	1.06
Scaling					
Shattered Slab					
Joint Seal	126	504	0.940	3.5	3.29
Pumping					
"D-line" cracking					
Remarks on Pavement Condition_____ Total					4.47 C ***
<p>Joint seal was hardened and often had missing sections. See Figure 4. Spalls were generally small with one or two exceptions.</p>

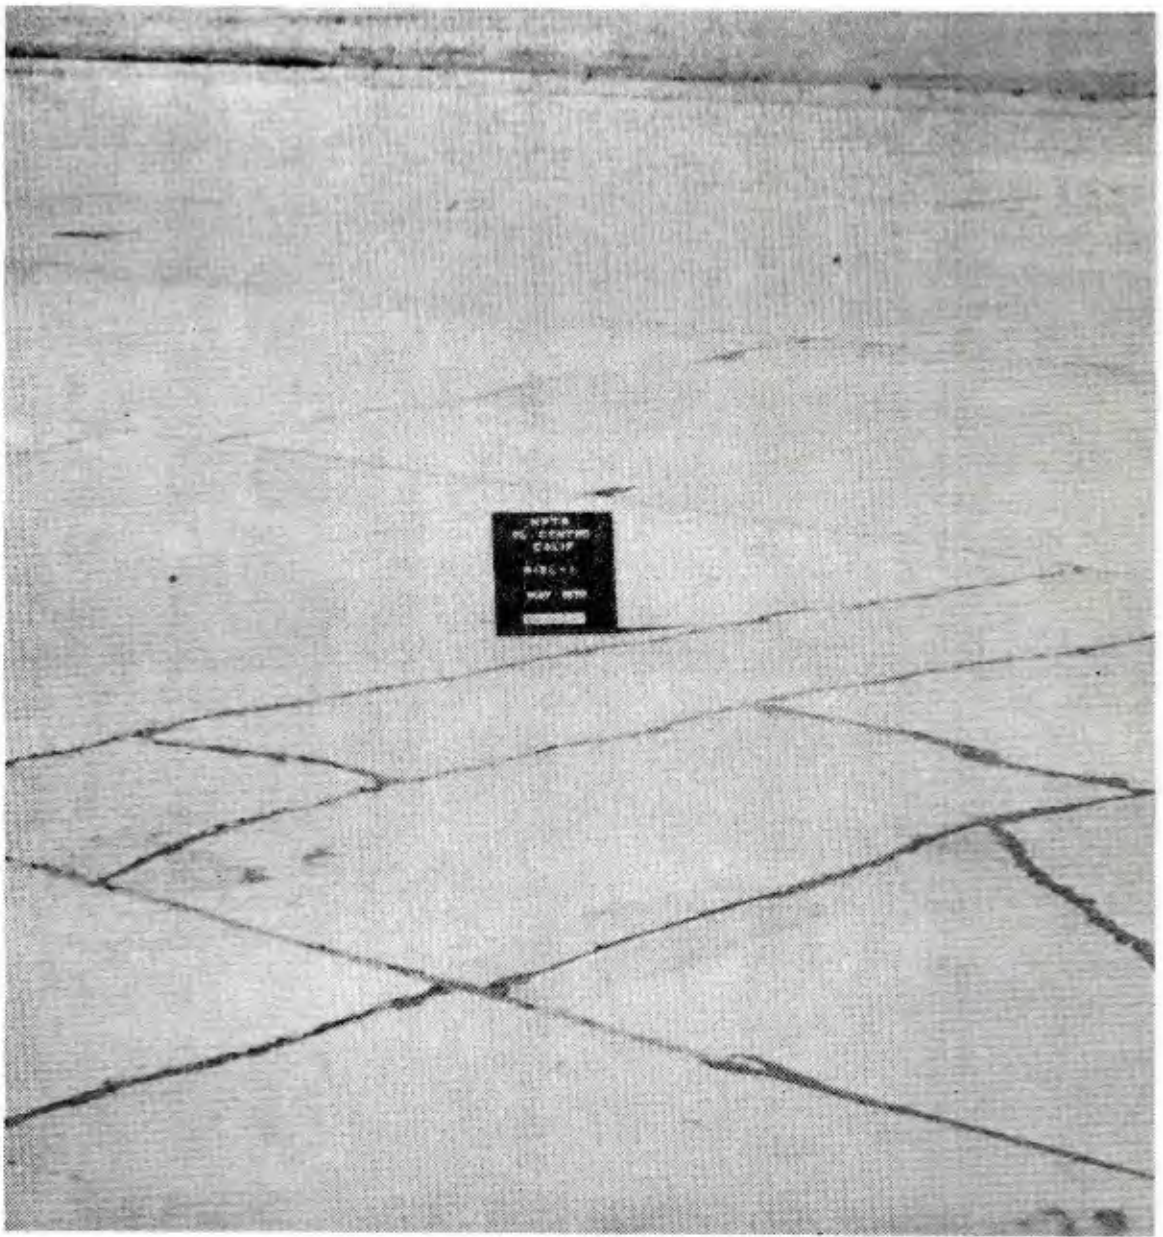
R12L-1: A repair project was completed on this section just before this condition survey. This project accounts for the drastic reduction in spalls and defective joint seal. As in discrete area R8L-3, the large number of transverse cracks is essentially unchanged confirming that these cracks occurred shortly after construction as a result of defective load transfer devices (Reference 3).

Figure 5. Shattered slab, Discrete Area R12L-1.

Defect Type	No. of Sample Slabs w/Defect	Total Slabs w/Defect: c x a/b	Defect Density (per slab) d/a	Defect Severity Weight	Weighted Defect Density e x f
	(c)	(d)	(e)	(f)	(g)
Faulting					
Corner Break	7	136	0.040	3.5	0.14
L.C. or T.C.*	76	1474	0.432	3.5	1.51
I.C.**	19	369	0.108	3.5	0.38
Depression					
Spalling	9	175	0.051	7.5	0.38
Scaling					
Shattered Slab	1	19	0.006	9.0	0.05
Joint Seal	13	252	0.074	3.5	0.26
Pumping					
"D-line" cracking					
Remarks on Pavement Condition _____ Total					2.72 C ***
<p>The few spalls remaining after the recent repair project were relatively minor. Station forces plan to repair these as funds become available. Generally, the cracks were sealed. See Figure 5.</p>
